Esthetic rehabilitation of malpositioned implants – A case report

Case Report

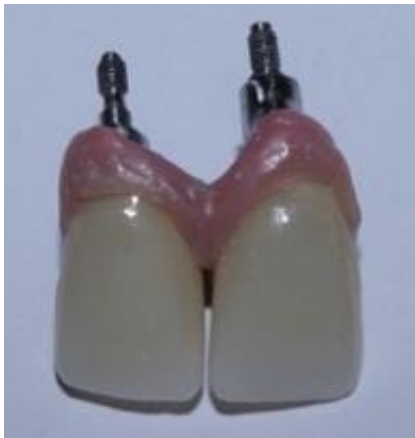
Fig. 11: Definitive prosthesis

Thereafter, the ceramic of the various parts of the definitive prosthesis were glazed. The abutment screws were tightened to a torque of 30N, followed by blockage of the screw-access hole with gutta percha and composite resin.

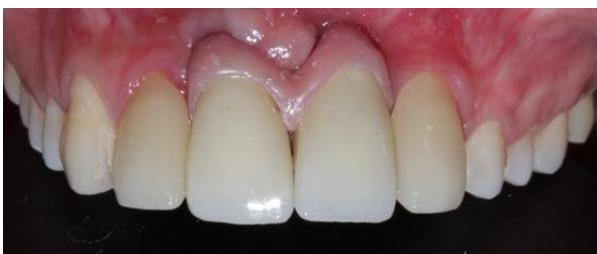
Fig. 12: Intra-oral view of definitive Paulo Malo prosthesis and laminate veneers

The zirconia crowns were cemented with a resin reinforced glass ionomer cement (Fuji Cem, GC) and the laminates with a resin cement (Calibra).
